RE: NEW SRV2 SIBERIAN FIRING PIN

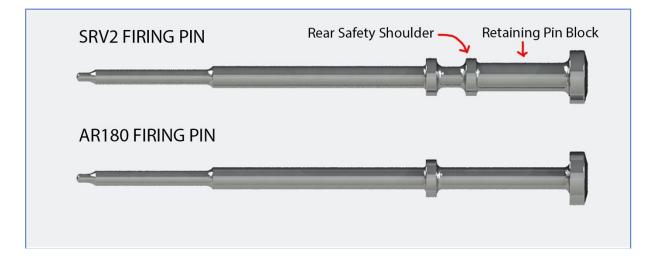
Diagram A

The first SRV2 Siberians shipped to customers use a standard AR180 firing pin. It has been determined that in very "unusual" circumstances, this firing pin could allow over-travel if the firing pin is stuck forward inside the bolt. The SRV2 Siberian now ships with a new SRV2 firing pin, which adds a safety shoulder behind the main shoulder, eliminating any possibility of over-travel before full lockup, which eliminates any possibility of the firing pin striking the primer before a bolt is fully locked up. The new firing pin also features a Retaining Pin Block that will not allow users to improperly install the firing pin retaining pin behind the rear safety shoulder.

Black Creek Labs will be immediately sending all current SRV2 owners that have an AR180 firing pin a new SRV2 firing pin. It is highly recommended that live ammunition is not used in the rifle until you install your new firing pin. Firing Pin style can be identified as per diagram A.
